Installatievoorschrift BARONGA | BINGARA vlakbouw
Installation instructions BARONGA | BINGARA flushmounting

BARONGA | BINGARA

Roestvast stalen spoelbak | Stainless steel sink

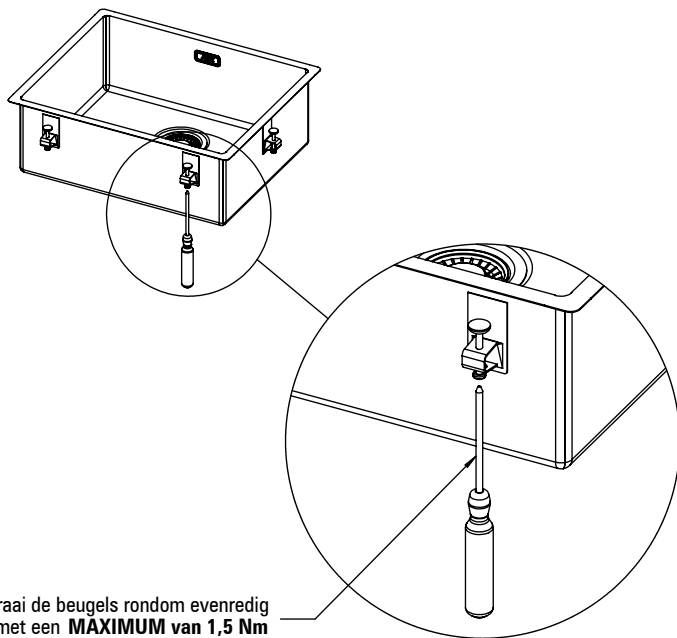
Draai de beugels rondom evenredig aan met een **MAXIMUM** van 1,5 Nm

Tighten mounting brackets evenly to a **MAXIMUM** of 1.5 Nm
