# BINGARA BLACK

Met de aanschaf van uw ABK InnoVent BINGARA geëmailleerde spoelbak heeft u gekozen voor een kwaliteitsproduct. Alvorens de spoelbak in gebruik te nemen, adviseren wij u deze gebruiks- en onderhoudsinstructie zorgvuldig te lezen. Bij normaal gebruik en zorgvuldig onderhoud zal uw spoelbak u jarenlang keukenplezier opleveren.

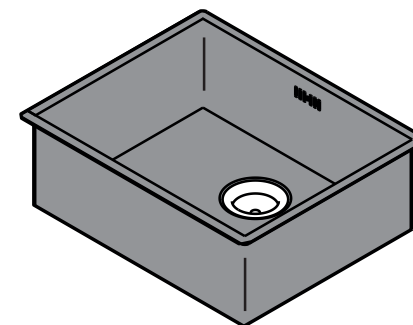
Korfplug zit niet exact in midden van het gat. [zie tekening] Mogelijk door spanning tijdens de montage van de afvoer is de korfplug niet exact in het midden geplaatst of is de centrale moer niet strak genoeg aangedraaid. Ga als volgt te werk: Draai de centrale moer los, positioneer de set opnieuw in het midden en draai de centrale moer opnieuw vast.

Basket strainer is not exactly in the middle of the hole. [See Drawing] Possibly by tension during the mounting of the drain plug, the basket is not exactly positioned in the center or the central nut is not tightened sufficiently tight. Proceed as follows: Loosen the central nut, position the set again in the middle and tighten the central nut.

- Bij gesloten korfplug loopt water toch via afvoer weg.

- When basket strainer is closed, water still leaks out.
